FULL RESERVE STUDY

The Hamlet Homeowners Association, Inc.

Williston, Vermont

May 5, 2020

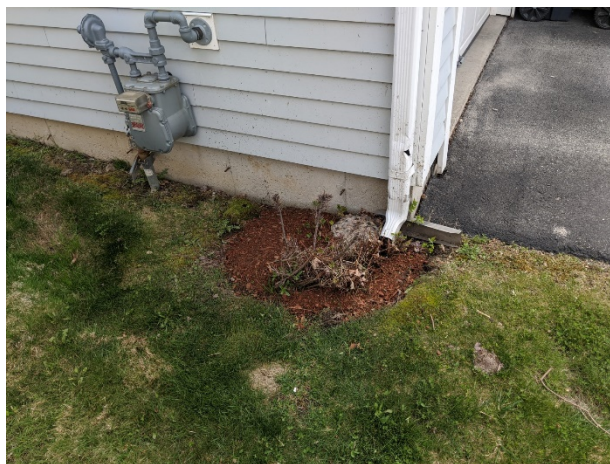
Condition: Good to fair overall with isolated downspout damage evident

Isolated downspout damage

Component Detail Notes: The useful life of gutters and downspouts coincides with that of the asphalt shingle roofs. Coordinated replacement will result in the most economical unit price and minimize the possibility of damage to other roof components as compared to separate replacements.

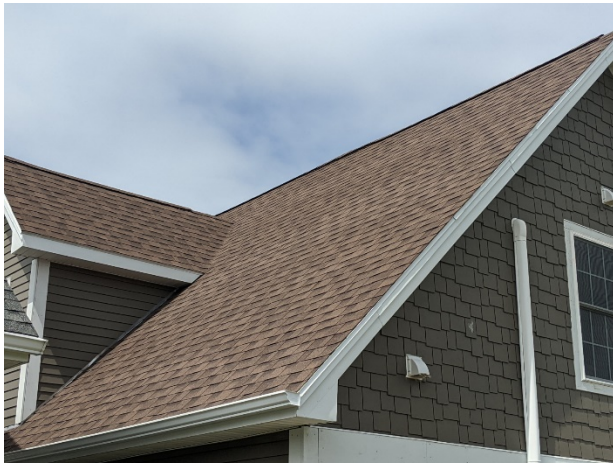
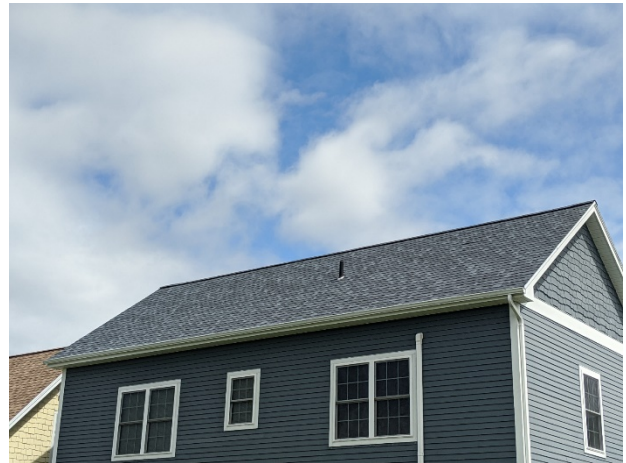
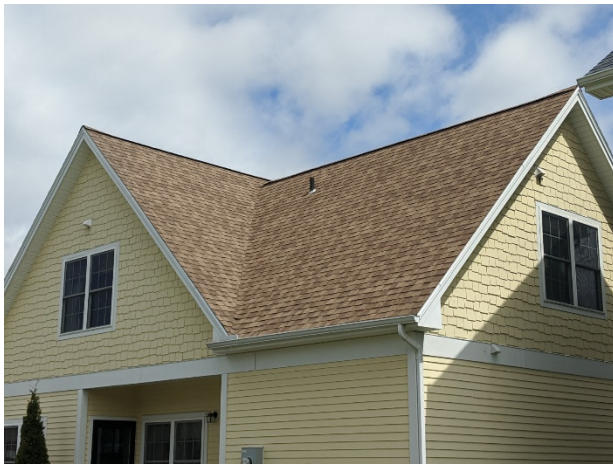
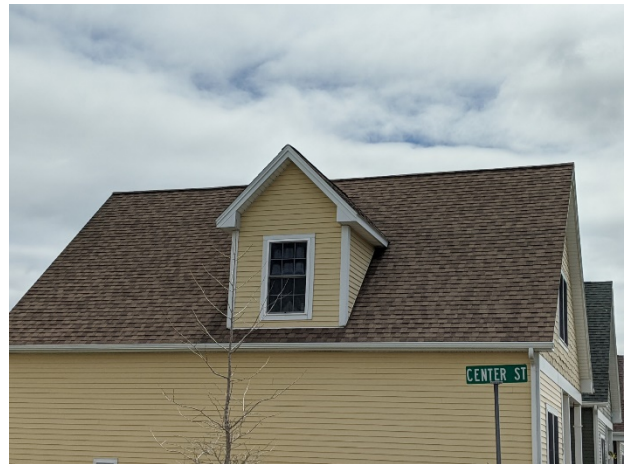
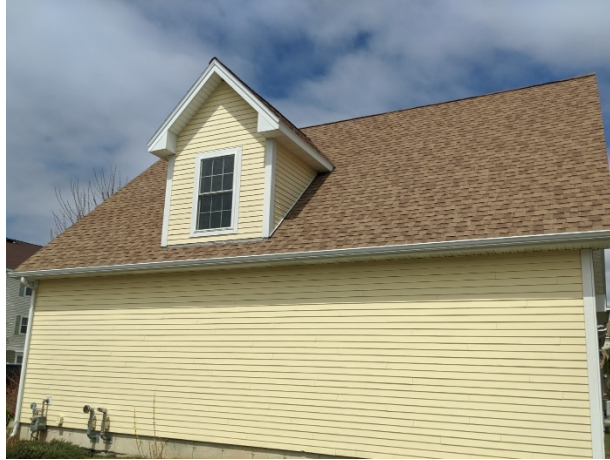
Condition: Good to fair overall. Management and the Board report a limited history of leaks.

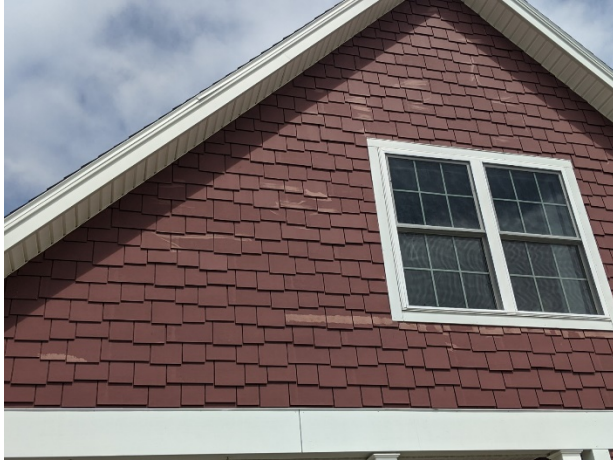
Condition: Good to fair overall isolated paint finish deterioration, previous repairs, siding gaps and siding damage evident

Paint finish deterioration at gable

- Paint finish applications
- Replacement of 700 square feet, or up to one percent (1%), of the siding and trim (The exact amount of material in need of replacement will depend on the actual future conditions and desired appearance. We recommend replacement wherever holes, cracks and deterioration impair the ability of the material to prevent water infiltration.)
- Replacement of up to fifty percent (50%) of the sealants at the windows and doors

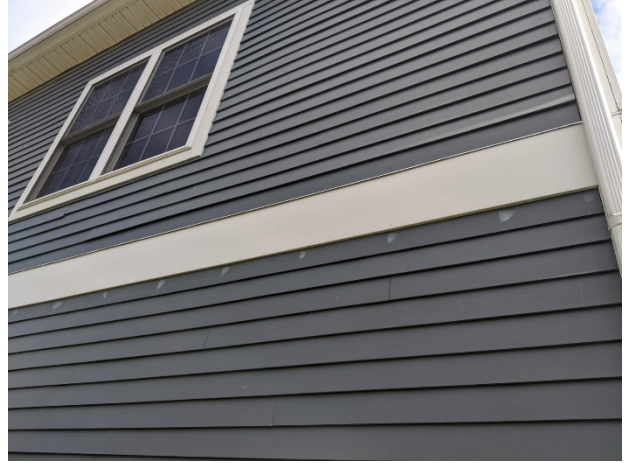
Unpainted fill at nails

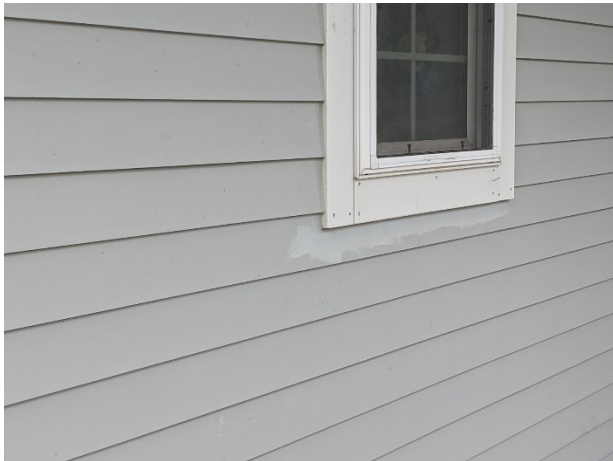
Paint finish deterioration

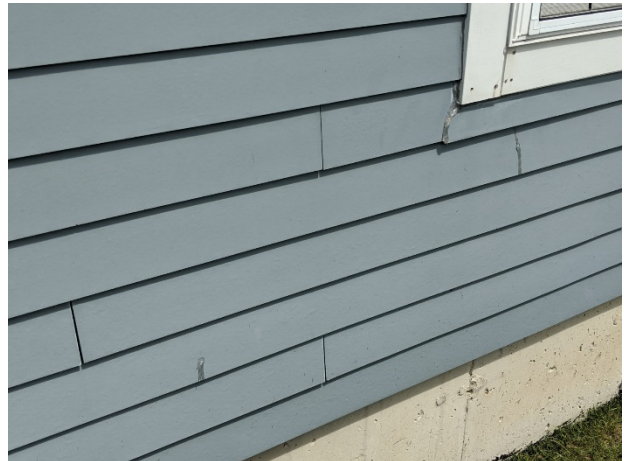
Siding damage and previous repairs

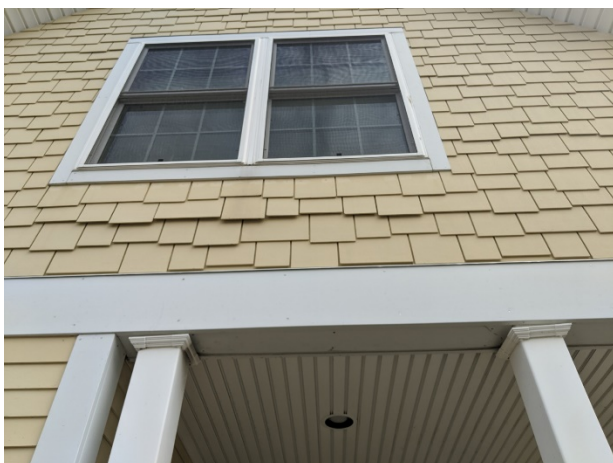
Gap between boards beneath window

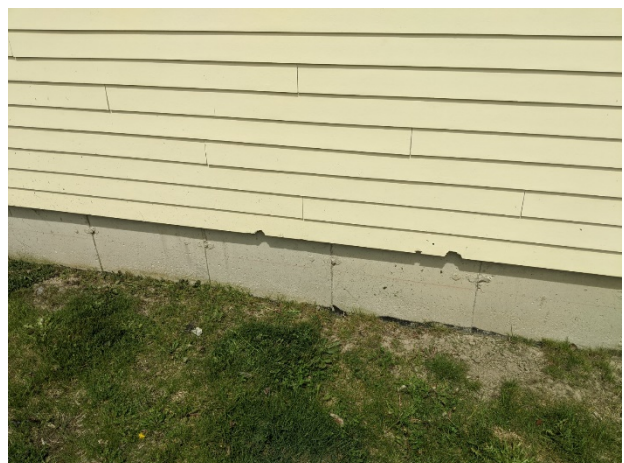
Damage along ground

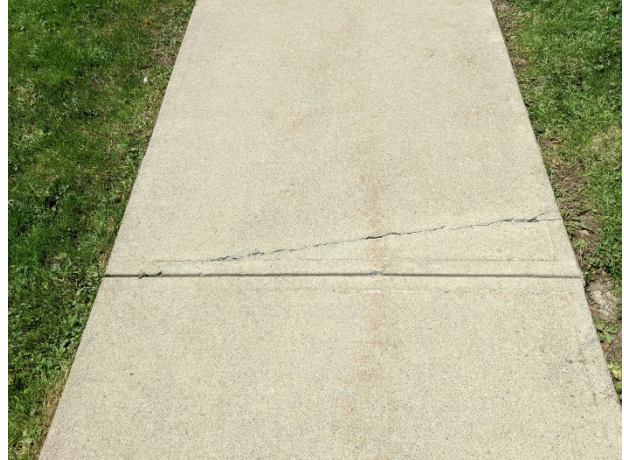
Condition: Good to fair overall with isolated cracks evident

Crack at common area sidewalk

Expenditure Detail Notes: Expenditure timing and costs are depicted in the **Reserve Expenditures** table in Section 3. We estimate that up to 1,245 square feet of concrete sidewalks, or forty percent (40.2%) of the total, will require replacement during the next 30 years.

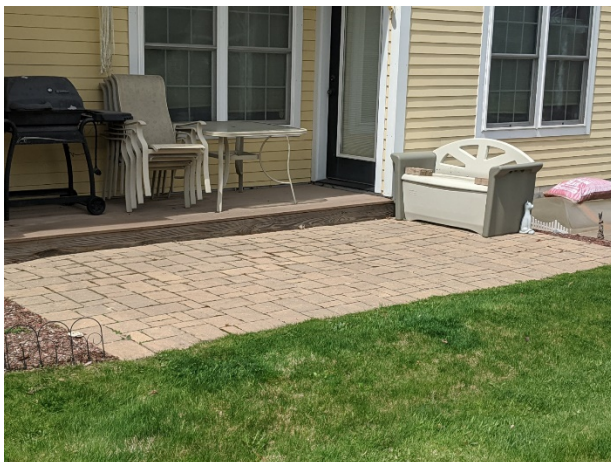
Condition: Good to fair overall with minor settlement and organic growth evident

Masonry paver patio

Note: Minor settlement and organic growth.

Expenditure Detail Notes: Expenditure timing and costs are depicted in the **Reserve Expenditures** table in Section 3. Our cost includes complete replacement of the pavers. We suggest the Association conduct interim resetting and replacement of minor areas of pavers as normal maintenance, funded from the operating budget.
